# **Teton River Subbasin**

## **2016 Total Maximum Daily Loads and Five-Year Review**

Hydrologic Unit Code 17040204

**State of Idaho  
Department of Environmental Quality**

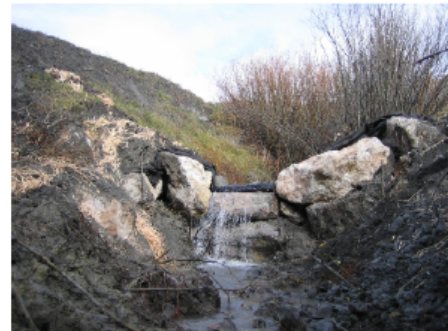
This rock structure was constructed in Horseshoe Creek to exclude non-native fish from the project area and stop head-cutting.

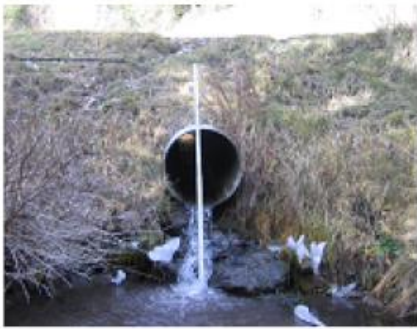
Horseshoe Creek culvert before replacement.

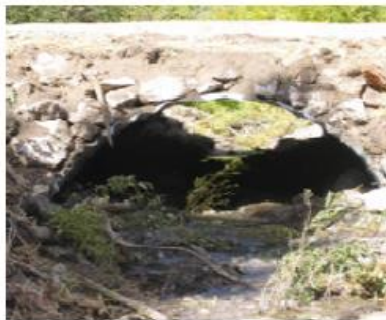
Crossing after culvert replacement.

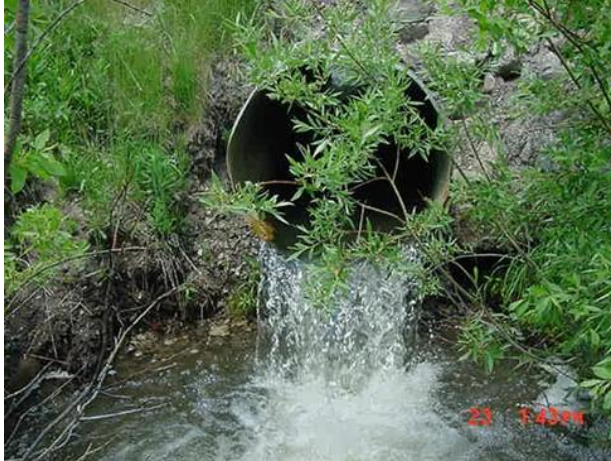
**Figure 9. Culvert before.**

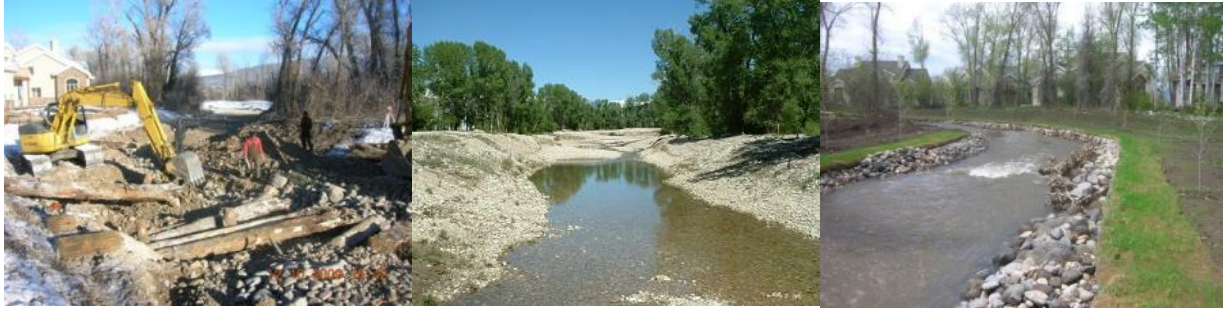
**Figure 15. Streambank restoration along Teton Creek.**

The project started in 2006 when FTR formed the Teton Creek Subwatershed Committee (TCSC) comprised of landowners, developers, and local, regional, and federal government agencies. The intent of FTR and the TCSC has been to develop a holistic approach to improve conditions on Teton Creek based on collaboration and community participation. The total project cost is estimated at \$3 million, which includes construction of an inset floodplain along the 6,100-foot project length and new Cemetery Road Bridge. Project construction was scheduled to occur in phases over several years and is dependent on funding. The majority of the project, Phases 1–3, were completed in 2013. The last phase will be completed in 2016 (Figure 15).

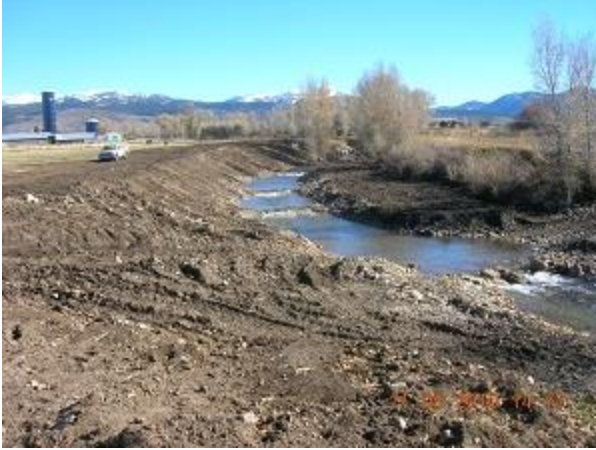
**Figure 16. Streambank restoration along Trail Creek.**

The project restored valuable fish and wildlife habitat and channel characteristics necessary for a healthy, functioning trout stream. Approximately 2,150 linear feet of channel were reshaped and stabilized using 4 rock weirs and 15 constructed riffles. Approximately 4,300 feet of streambanks were stabilized using bioengineering streambank stabilization techniques including willow clumps, vertical bundles, and willow poles. Inset floodplain benches were added and planted with native vegetation to dissipate flood energy, help capture sediment, and enhance riparian vegetation. Sinuosity was enhanced by reshaping stream bends. The project was completed in November 2010. Partners included Travis Thompson (Victory Ranches LLC), Aqua Terra Restoration, the Natural Resources Conservation Service, Trout Unlimited, USFWS, North Fork Native Plants, and Silver Star Communications.

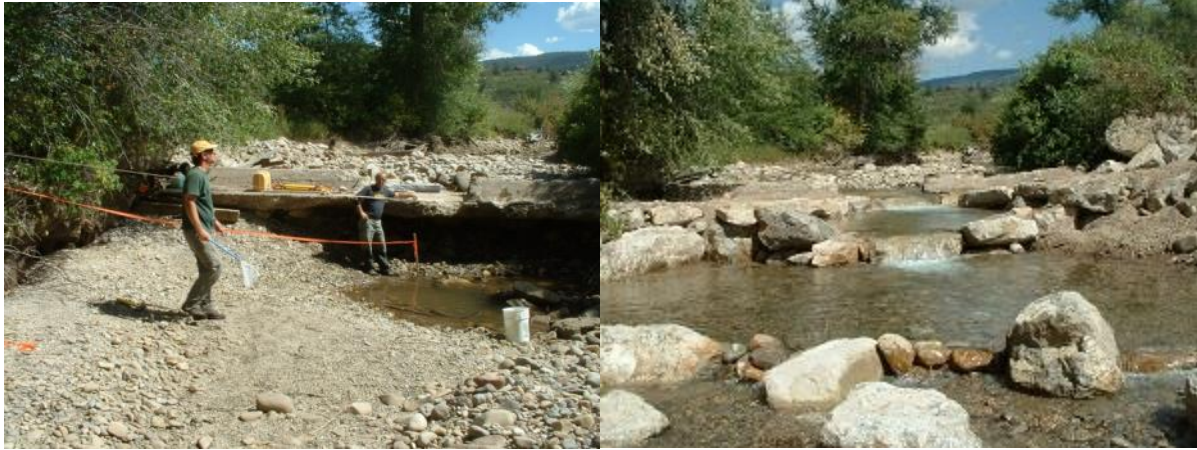
**Figure 17. Check dam and fish passage improvements on Trail Creek.**

To accomplish project goals, FTR installed an A-frame vortex weir positioned in a stepped configuration downstream of the weir. The A-frame weir was designed to create a series of pools, with the water surface of the uppermost pool at the approximate elevation of the top of the diversion weir, thereby eliminating the drop. Large rock fill was placed in the undermined section of the diversion weir to further stabilize the structure. Project partners included the Idaho Department of Fish and Game, On-the-Rocks Aggregate, and Trail Creek Nursery.

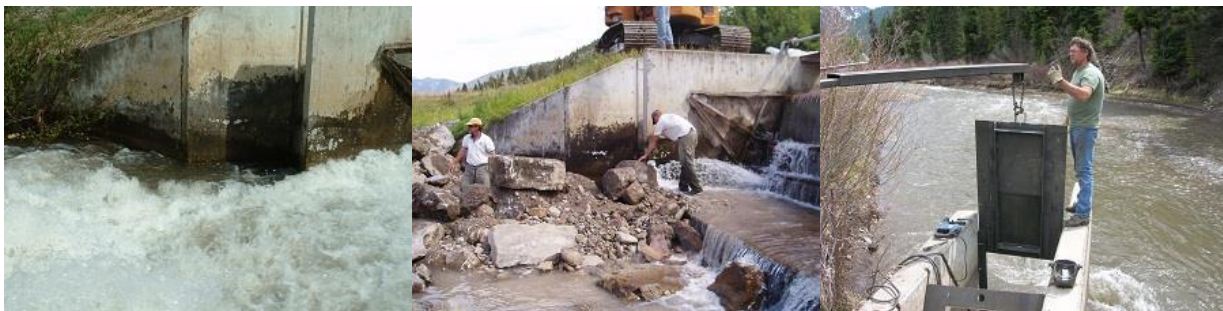
**Figure 18. Fish ladder improvements on Trail Creek.**

One component of the project was designed to construct a new entrance pool large enough to submerge the first fish ladder plate, thereby significantly reducing velocities at the ladder entrance. The other component of the project was to lower velocities within the ladder by replacing panels that had been removed and installing a new orifice plate at the upstream end of the ladder. A fish trap was installed in 2006 at the upstream end of the fish ladder. Numerous improvements were made to the trap in 2007 and 2008. In July 2008, FTR found fish in the trap indicating that the fish ladder was working. Project partners included IDFG, USFS, On-the-Rocks Aggregate, Trail Creek Nursery, and Majestic Mountain Metal.

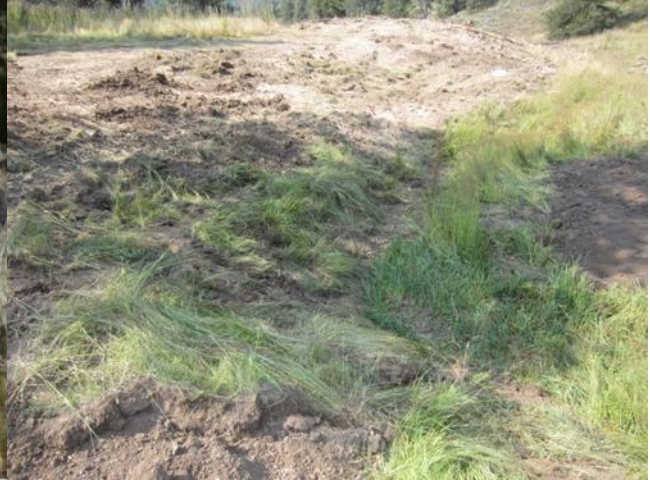
**Figure B5. A 2015 project resloped vertical banks and replanted sod mats next to the stream. Willows were planted, the area was seeded, and an undersized culvert was replaced.**

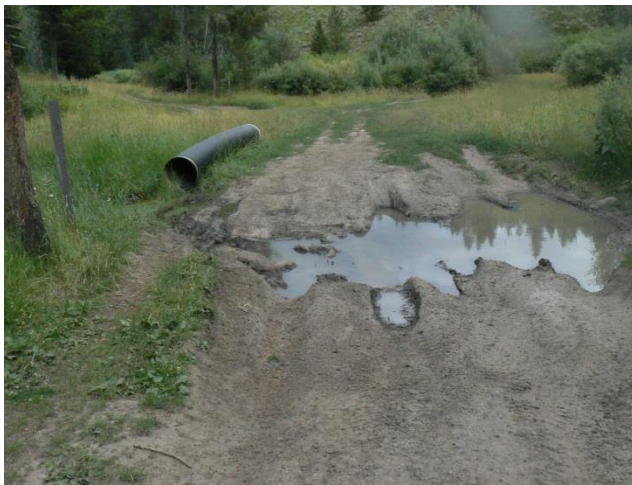
**Figure B6. Crossing on Fish Creek (before).**

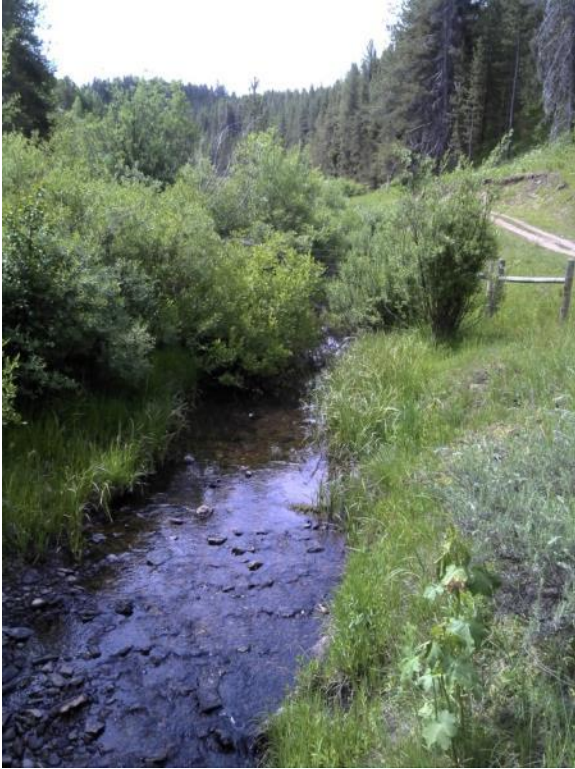
**Figure B8. South Fork Moody Creek, showing bank stabilization and fencing.**

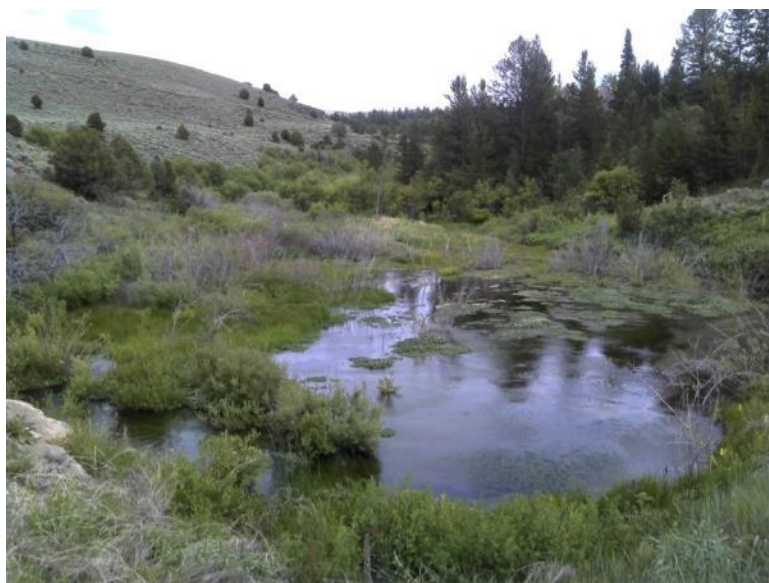
**Figure B20. Ponded channel above road, site of BURP 1997SIDFL018 with failing habitat scores.**

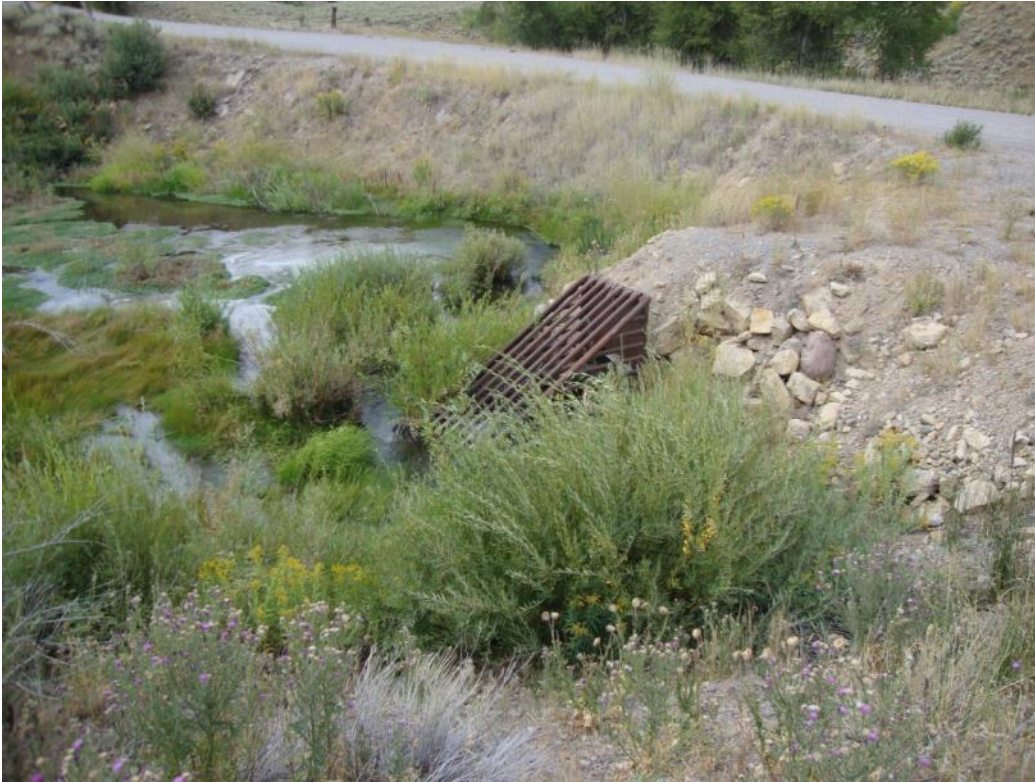
**Figure B21. Culvert on Warm Creek just upstream of confluence with Canyon Creek.**

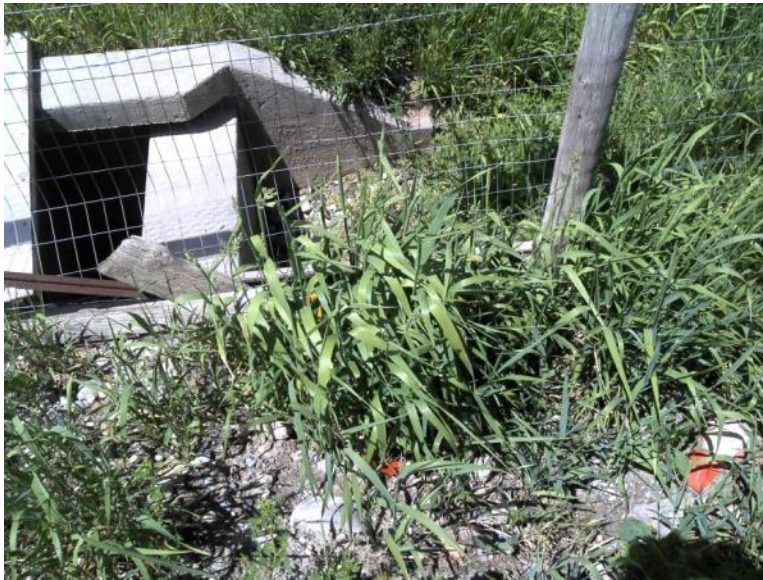
**Figure B24. Example of flumes and headgate structures.**

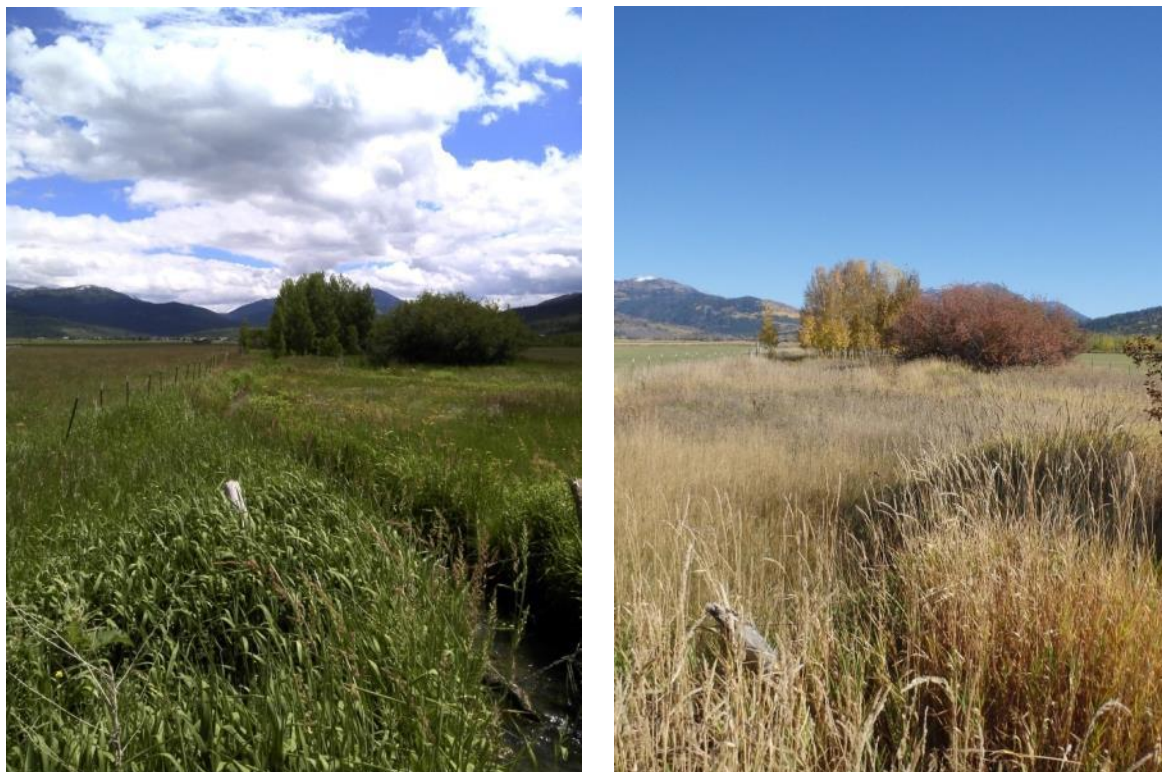
**Figure B25. Historic channel straightening along recent exclosure fenceline.**

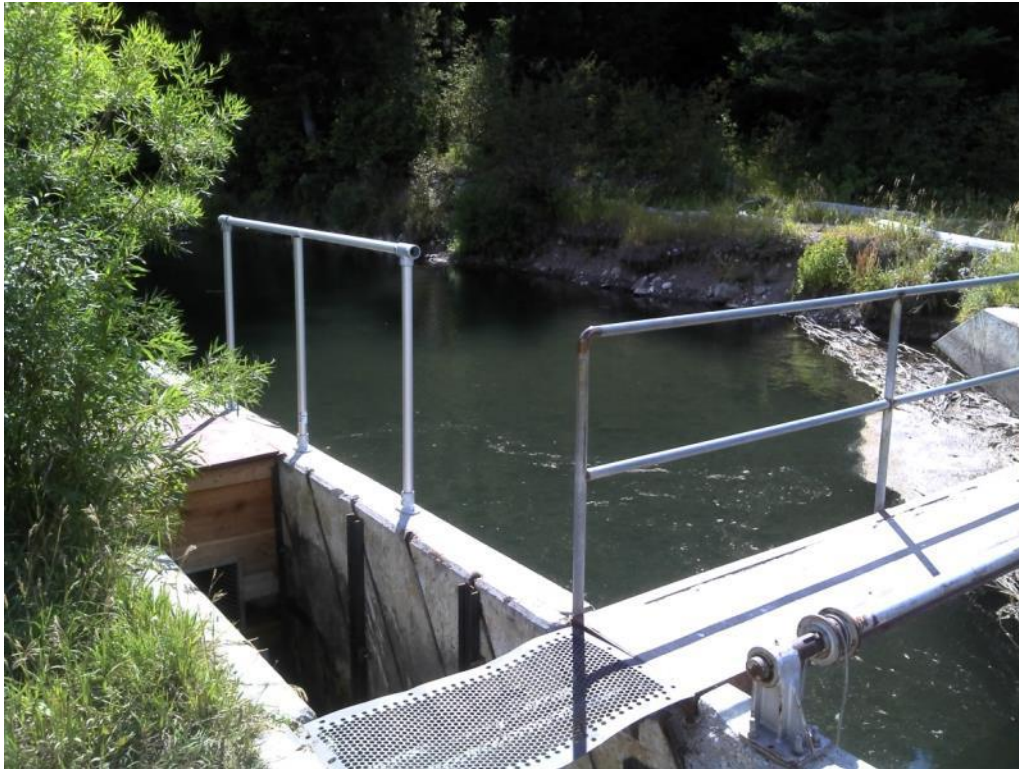
**Figure B27. Pipeline diversion structure.**

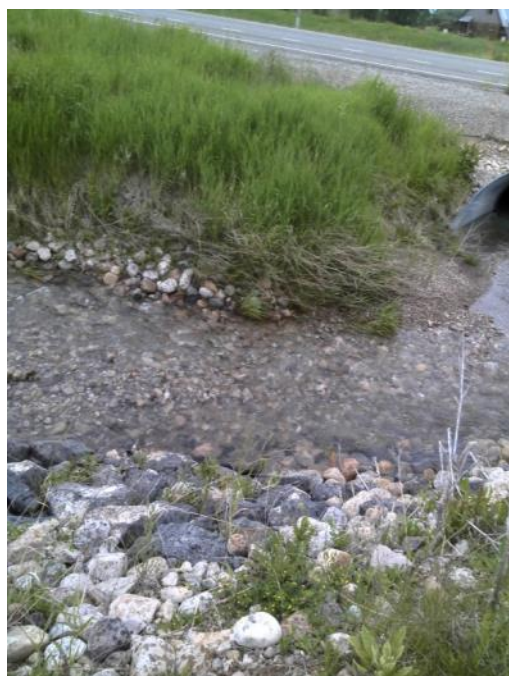
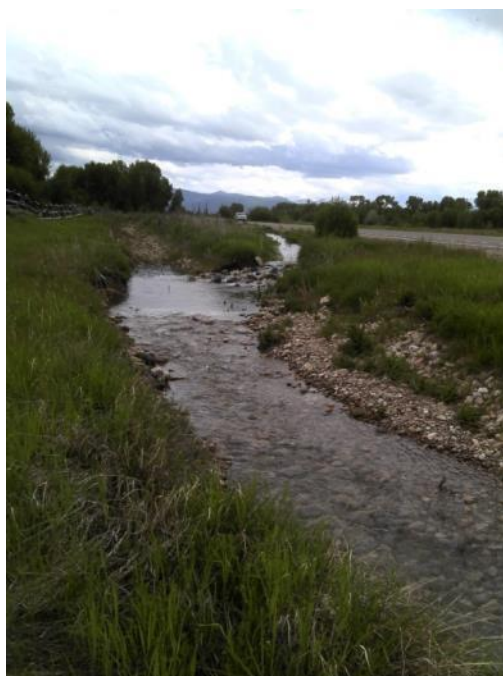
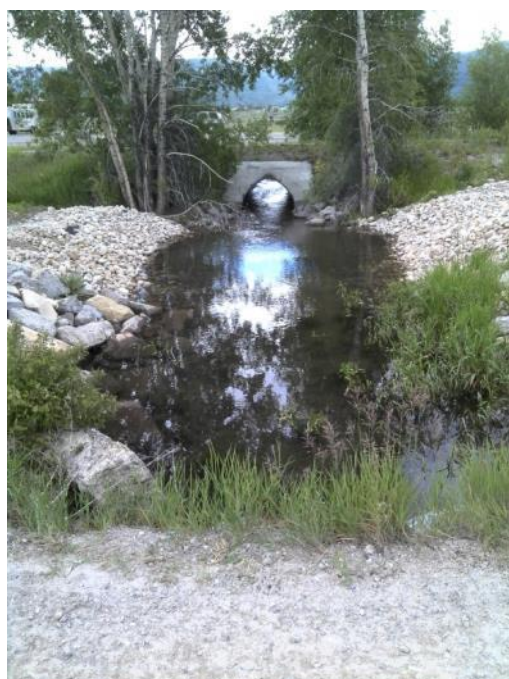
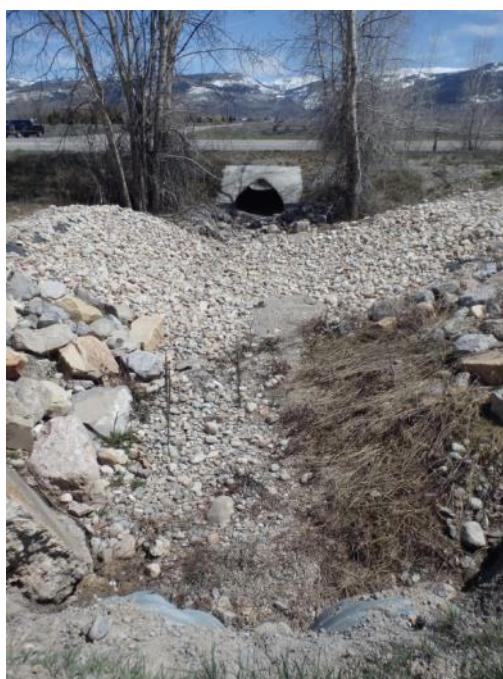
**Figure B34. Dick Creek (canal portion) near 1997 BURP location and Highway 33 in June 2013 (left) and May 2014 (right).**

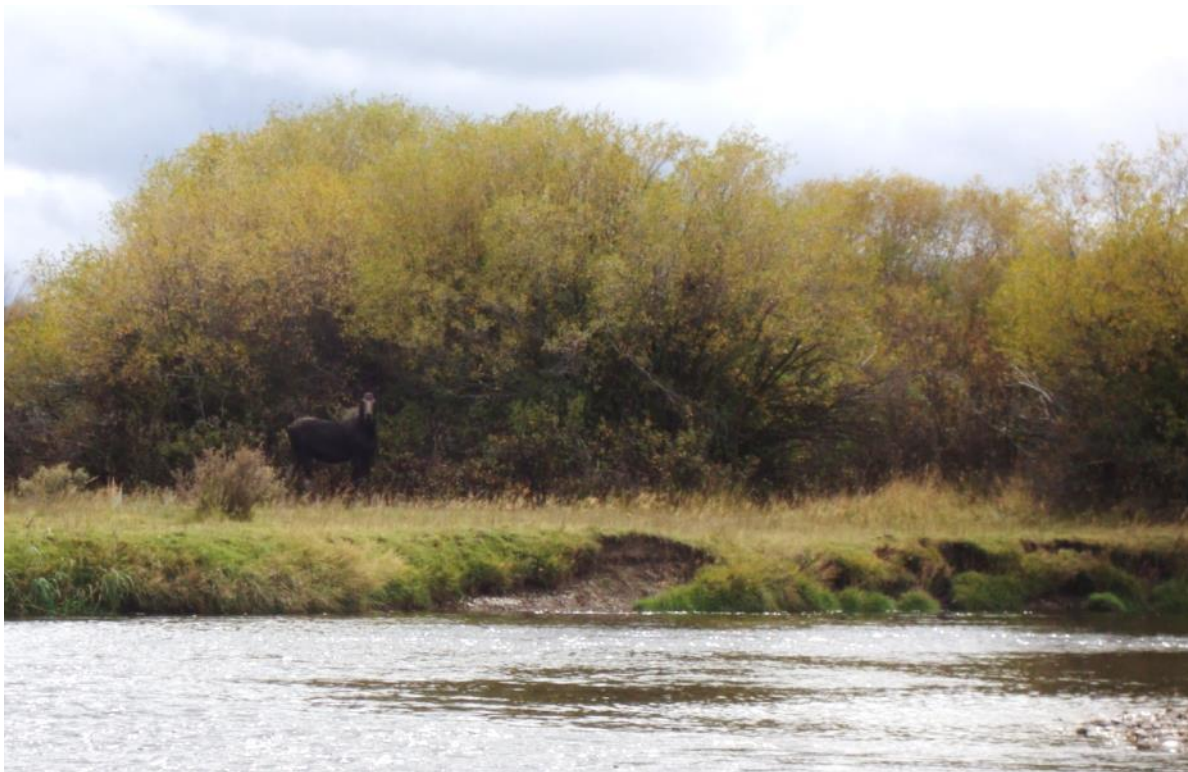
Eroding—generic slumps etc. assumed to be caused by ground water seepage

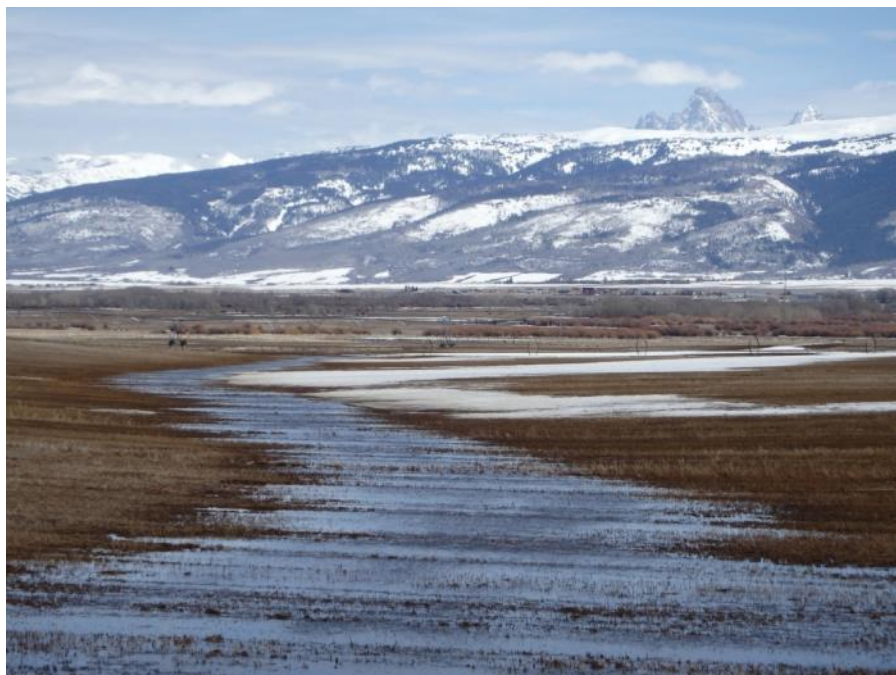
Note vegetated swale filter strip with different, presumably permanent, cropping pattern than areas to either side.
